Sardinia, 2017

Kudjape landfill

Baltic Sea, Estonia, Saaremaa

Closure of the Kudjape landfill

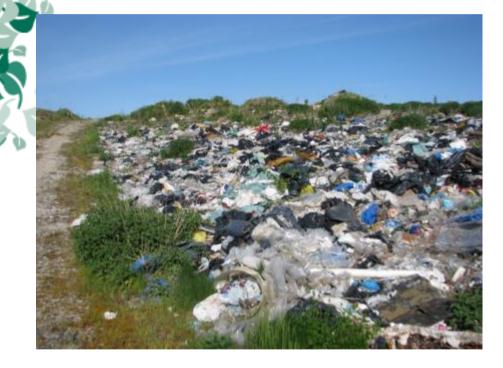
Kudjape Landfill, Saaremaa island, Estonia

- Mostly municipal waste
- In operation 1970 2009
- Estimated volume 200 000 m³
- By law: had to be capped 2013
- Main issue: landfill gas
 - Gas collection? Passive ventillation?
 - Gas degradation?

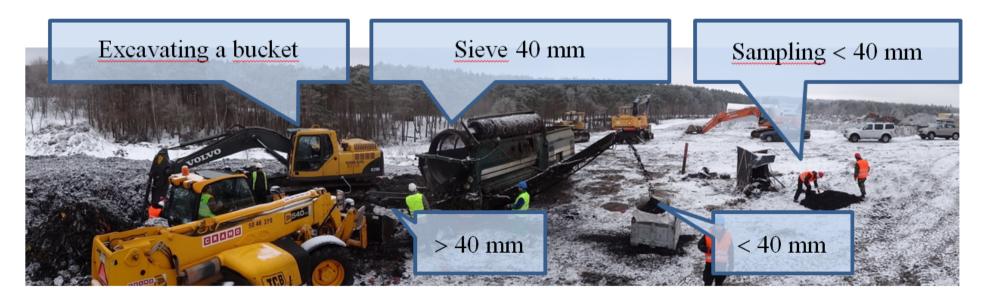
- Regulation of the Ministry of Environmental Board
 - 1.2 m thick final cover + 0.5 m gas distribution layer
 - Alternative cover for landfill biocover
 - Problems because of the location
- Is it possible to extract the material for bicover from the landfill?

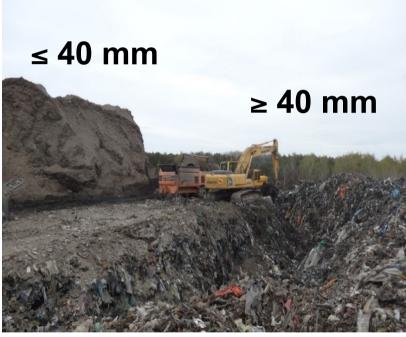
Fine fraction

- Screened with 40 mm drum sieve
 - Totally 57,777 m³;
 - coarse/fine = 70:30
- Cover layer composition:
 - 60% fine fraction (FF) ≤ 40 mm
 - 20% naturally available soil
 - 20% matured sewage sludge compost

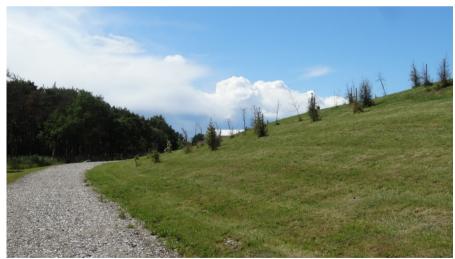
Tree growth

- European larch (Larix decidua) and Norway spruce (Picea abies) were planted
- High mortality rate two years after planting
- Field works started in autumn 2014
 - Height of the trees
 - Soil moisture and pH
 - Temperature
 - Conductivity
- Research continues
